Surface characterization of GaAs photocathodes and high current operation experience at the JLab FEL

> Photocathode Workshop, Cornell University, Ithaca NY October 8-10, 2012

Motivation

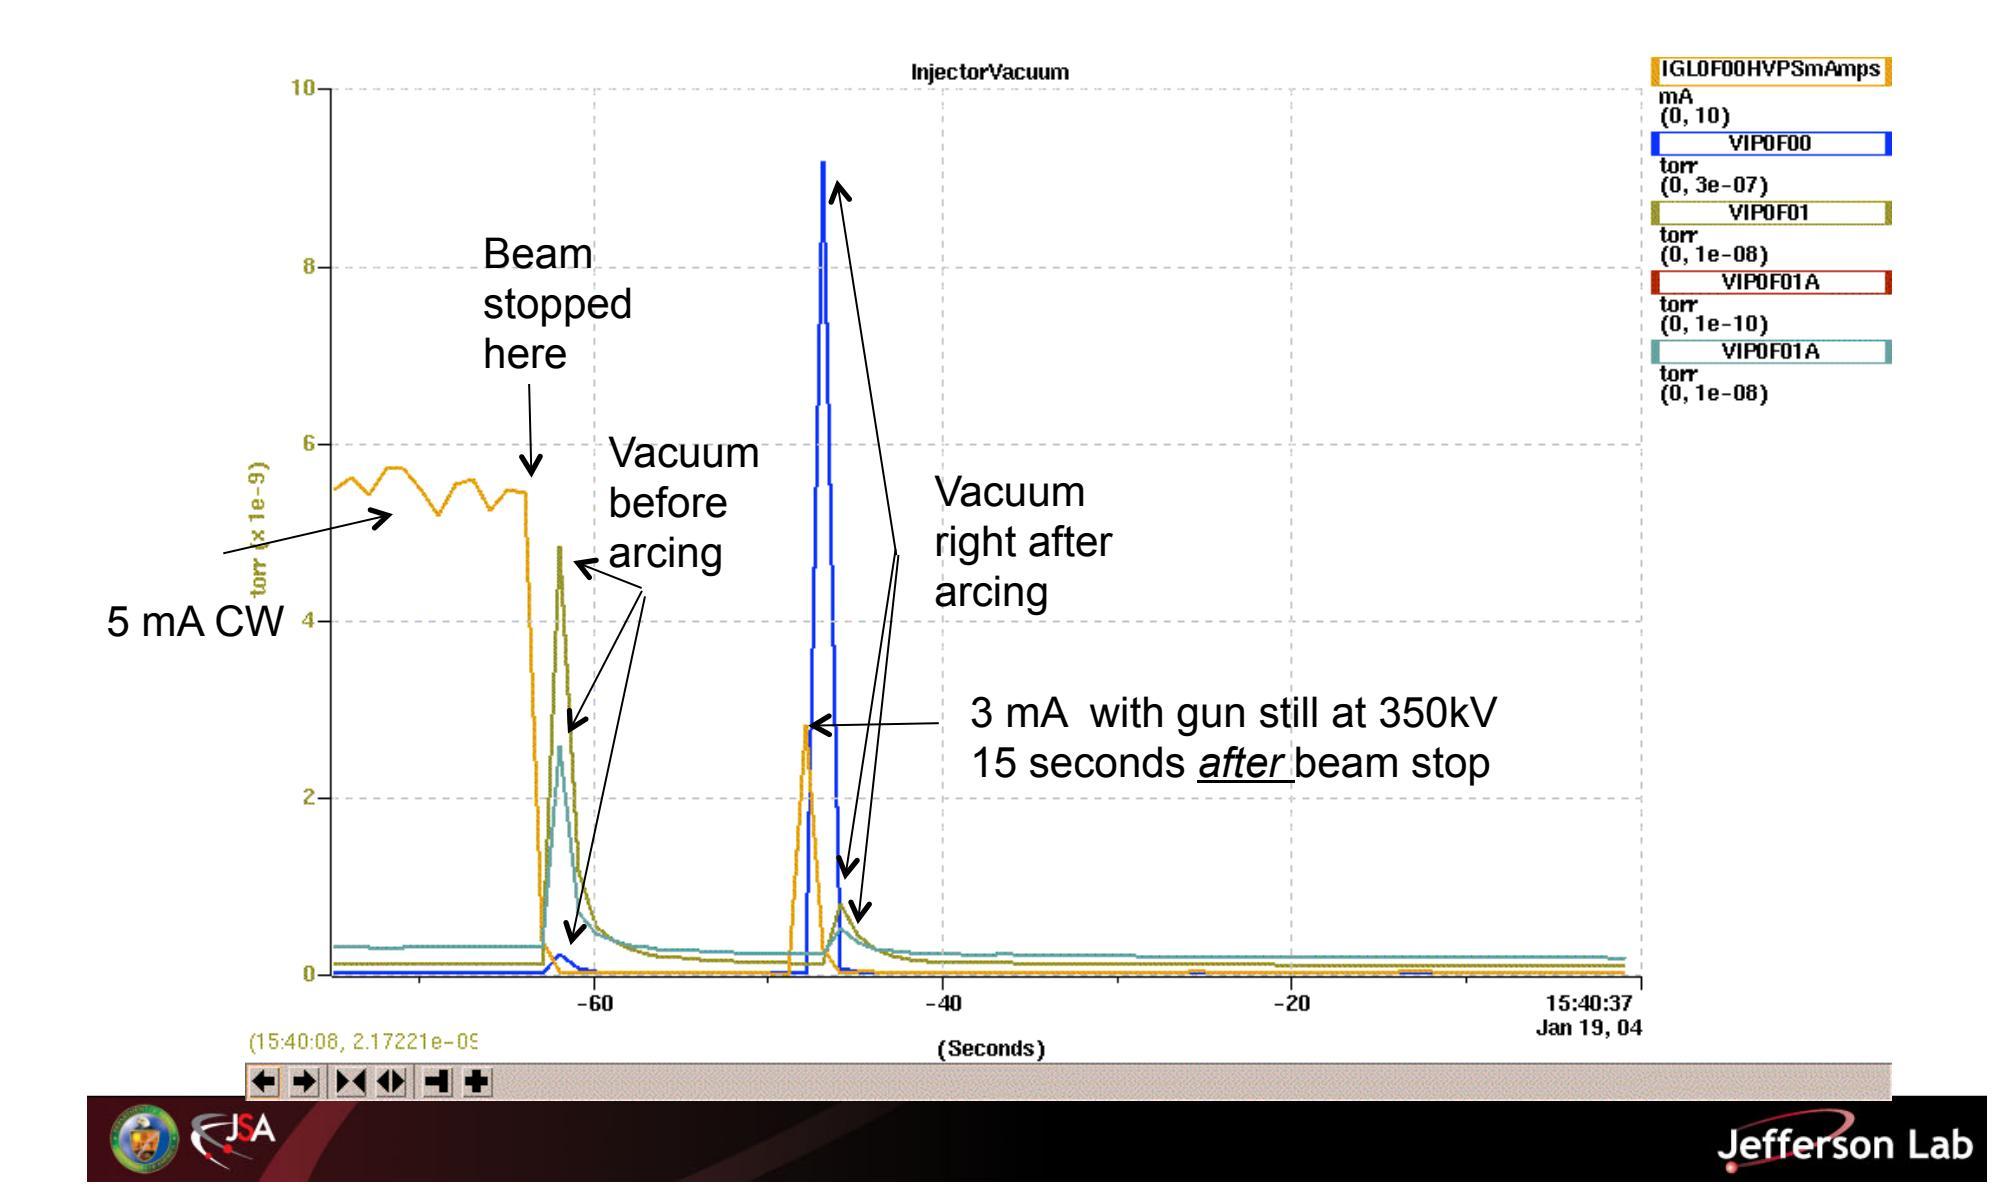
At least 3 mA of current at 350kV during the cathode 'arcing'

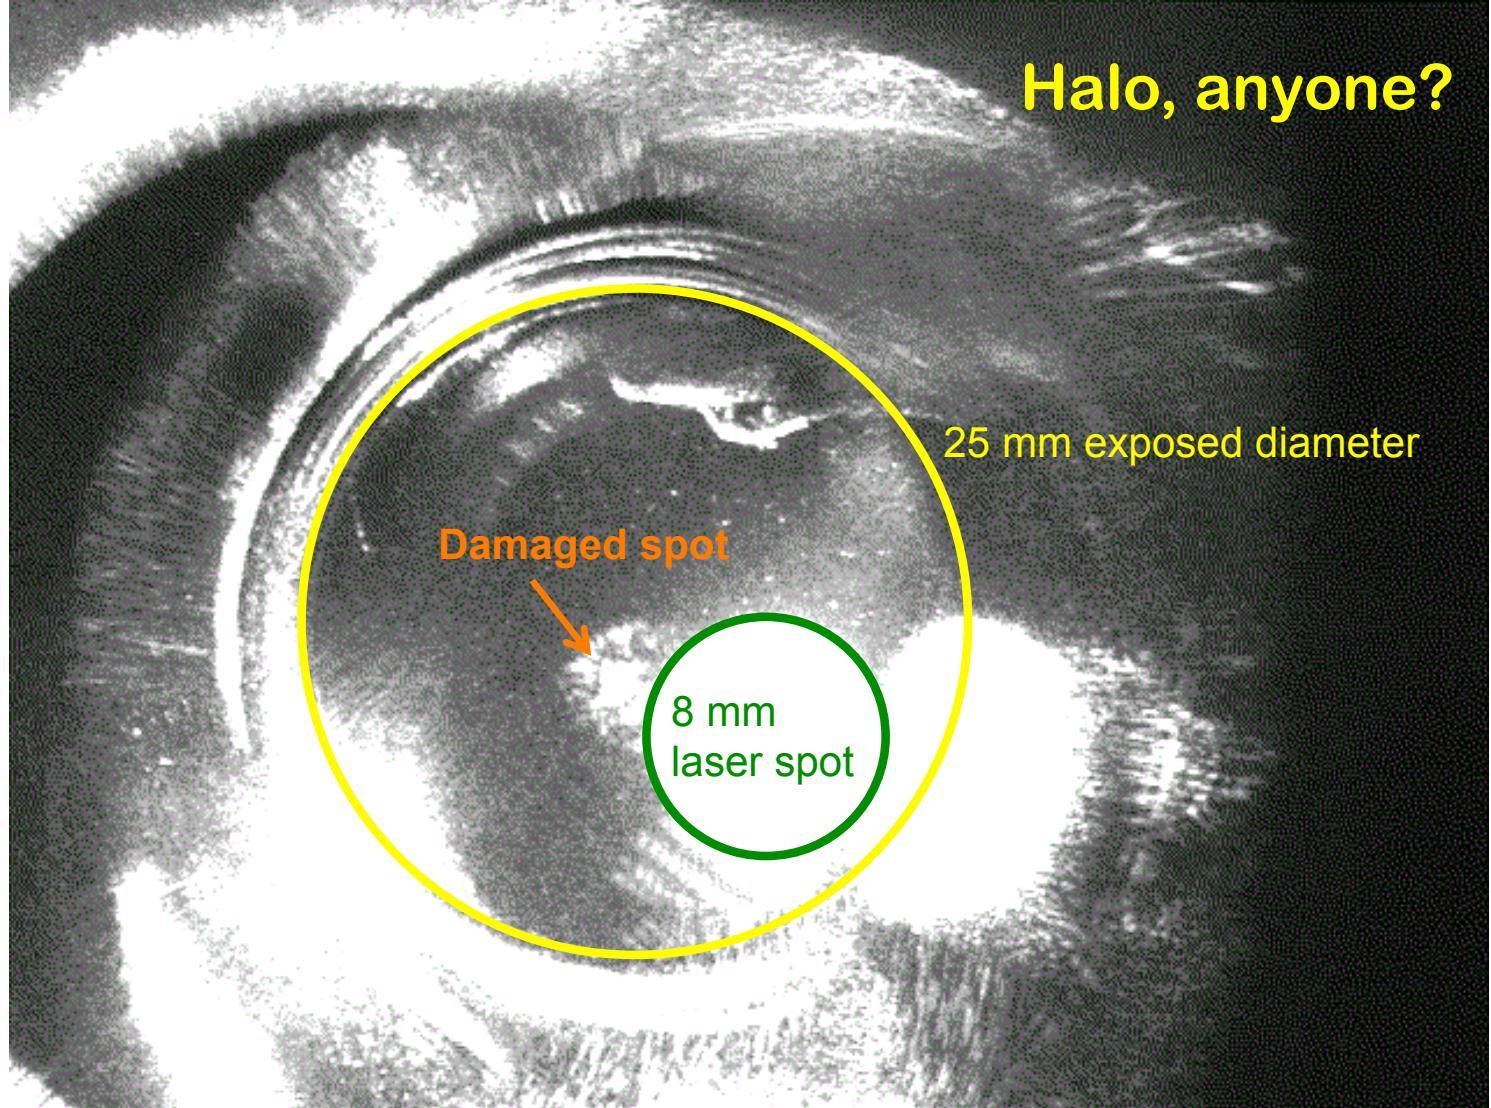
Picture of sample "A" while operating at 7 mA CW

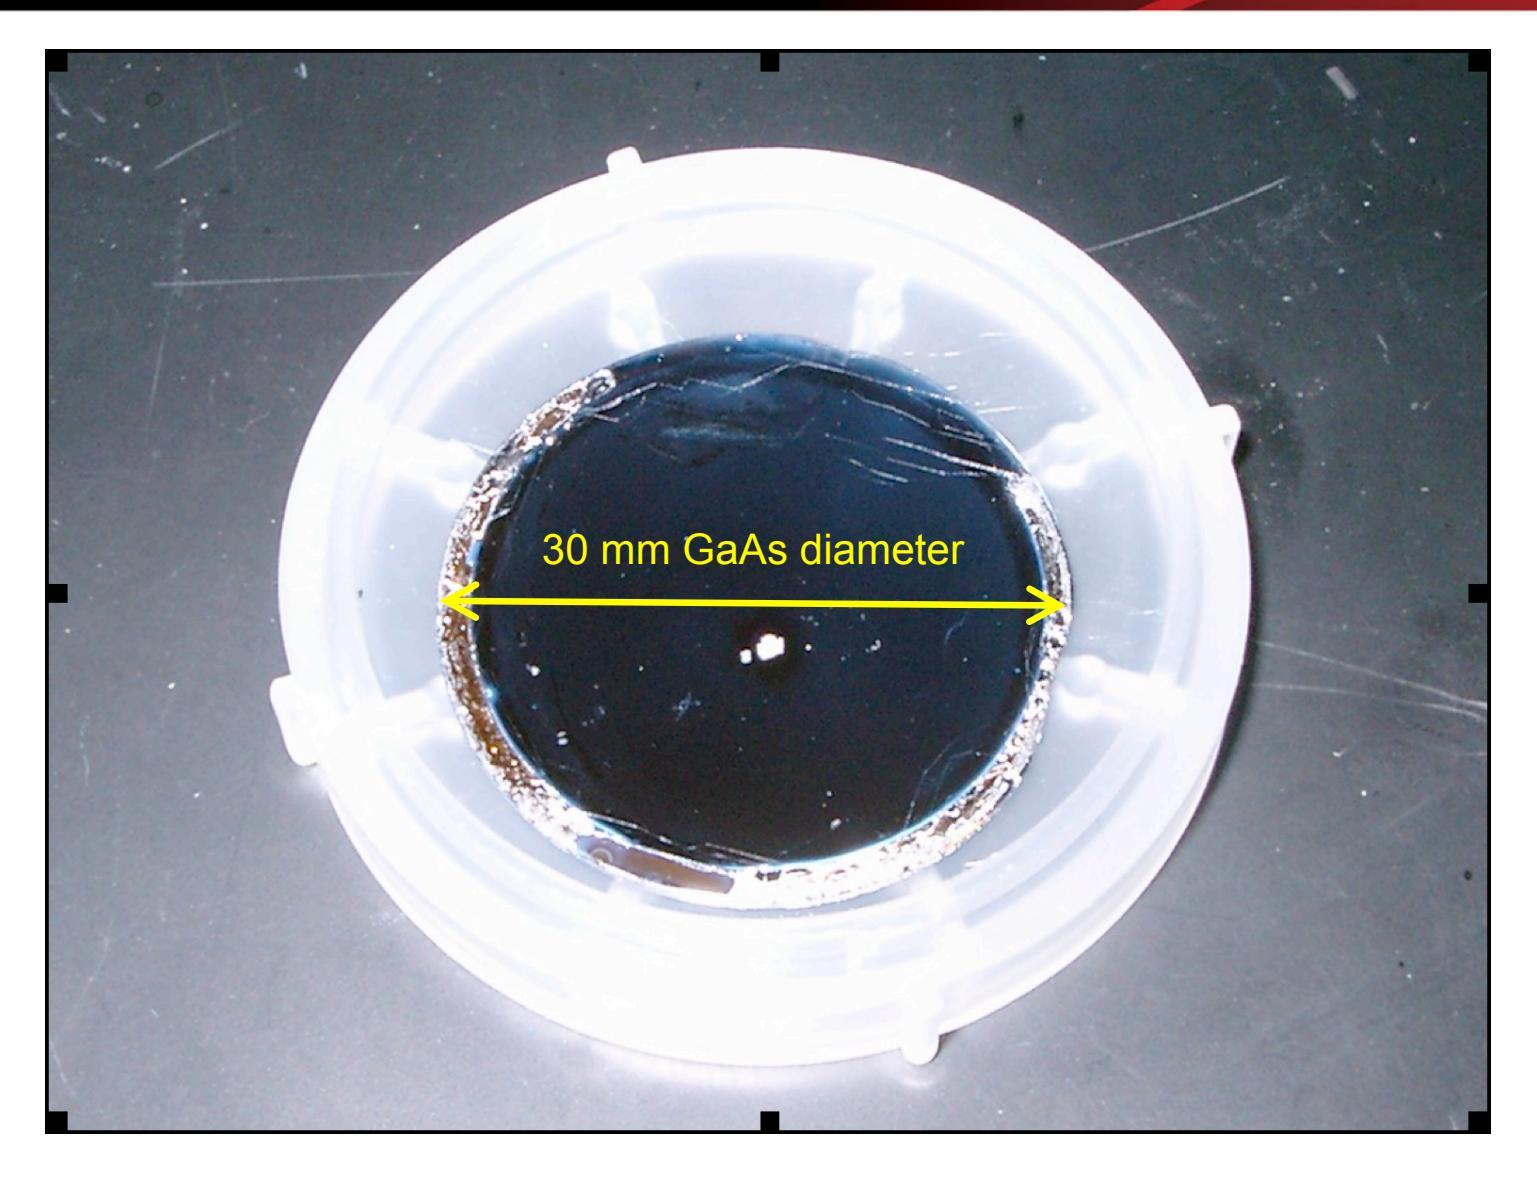
- Installed in FEL gun in 2003
- Operational at 350kV
- Operated reliably at 5 mA CW
- Achieved 9 mA CW for a few minutes
- Stable FEL operation >5 mA CW limited by halo
- In particular FEL operation > 8 mA CW often led to sudden beam stop
 - resulted in total loss of QE and produced damage spot
 - QE fully recovered by heat clean and subsequent NEA reactivation
 - observed increased beam halo after each event
- Removed from gun in 2004 b/c of excessive halo

Sample "A" removed from gun in 2004

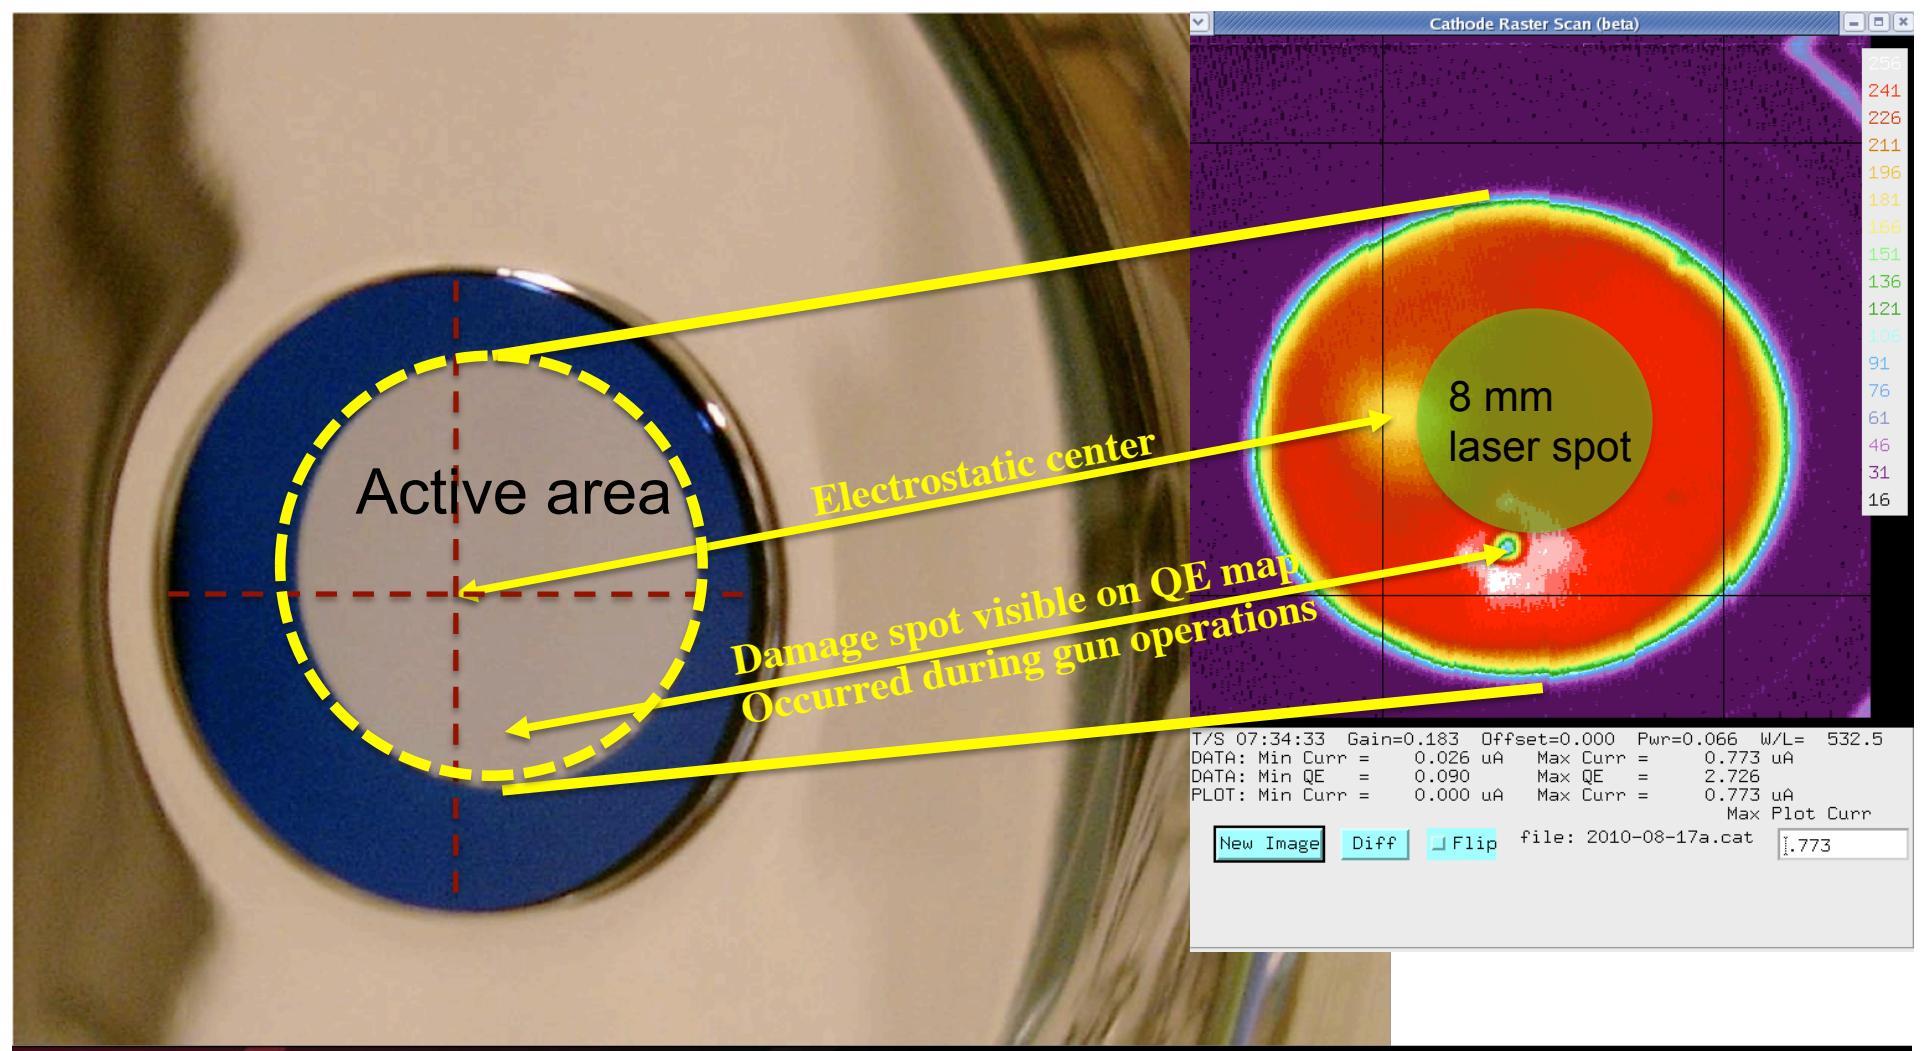
Picture of sample "B" mounted to the gun electrode and corresponding QE map

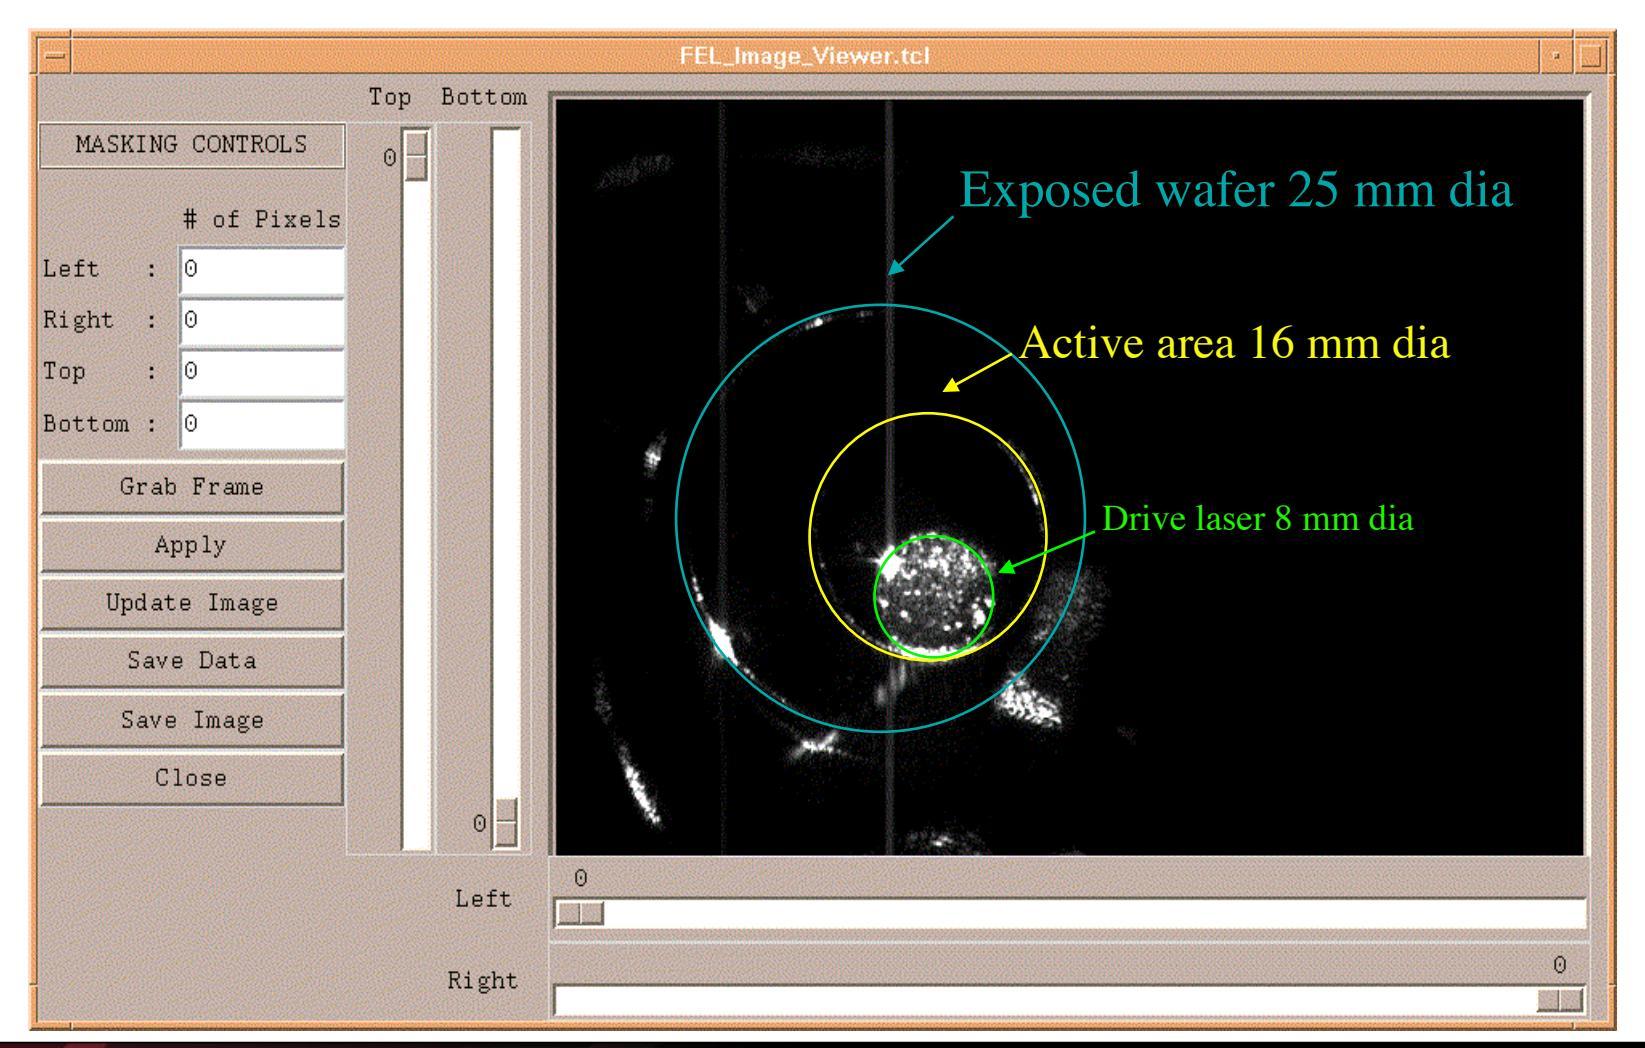
Picture of sample "B" taken while delivering 5 mA CW

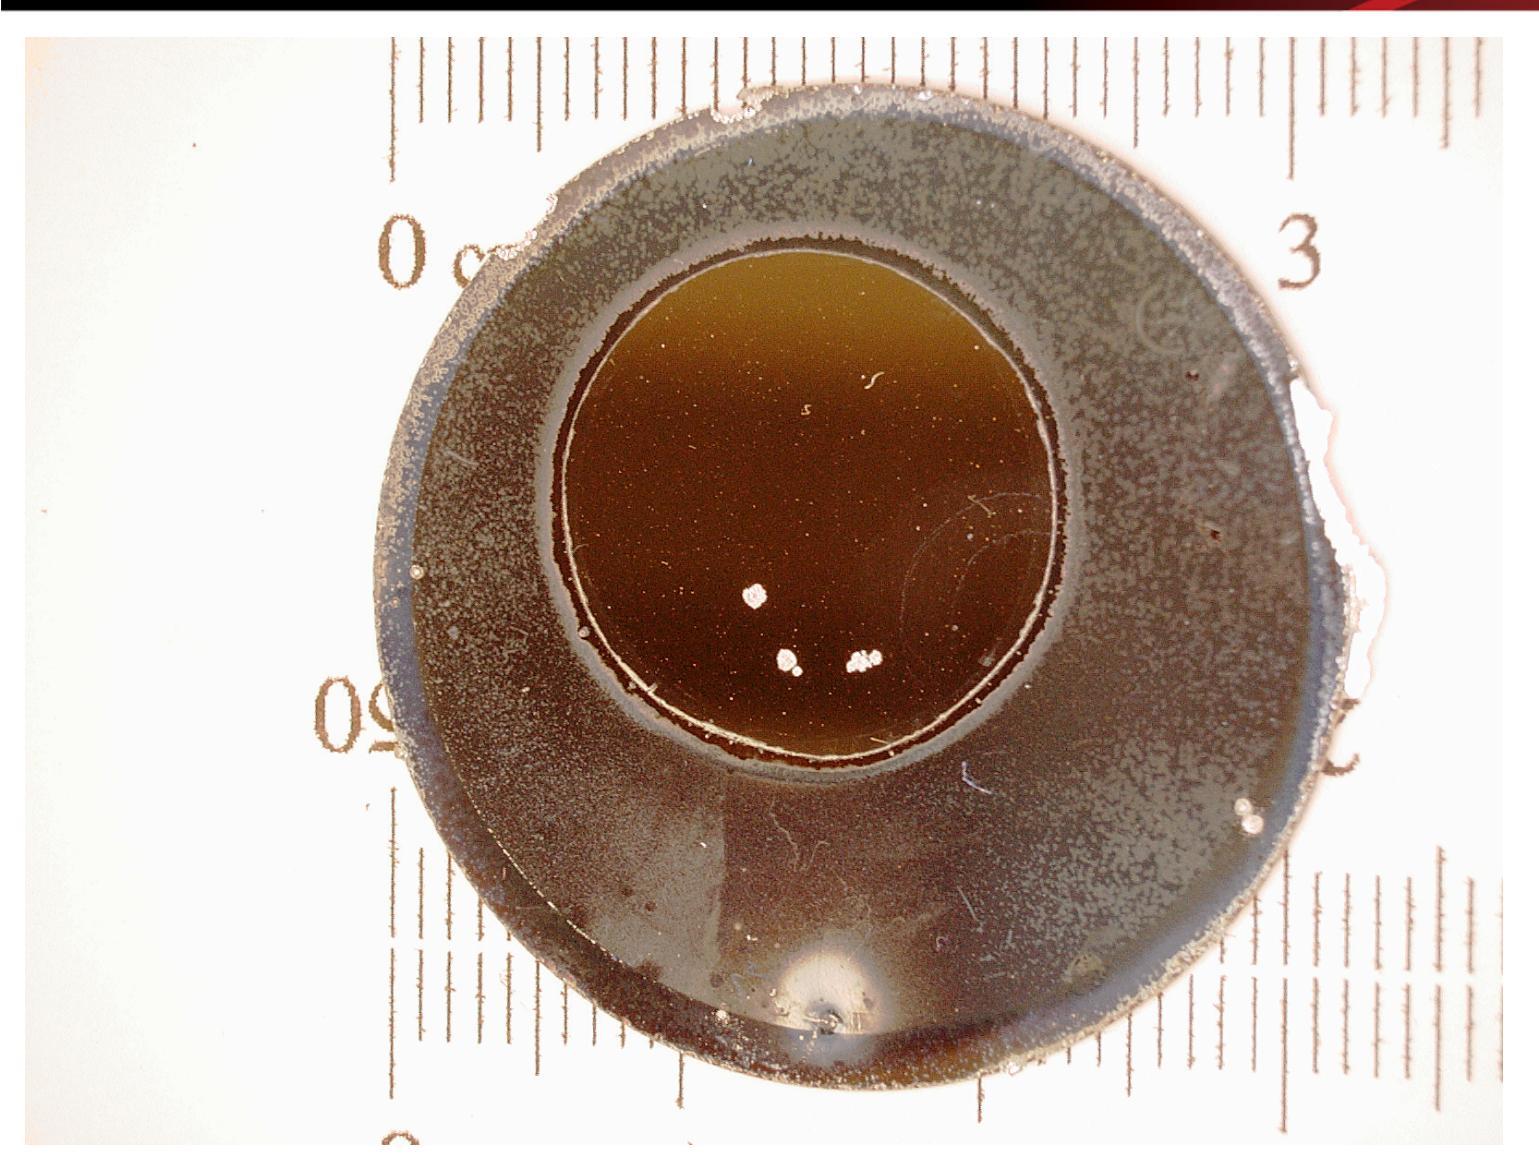
- Sample was anodized to reduce beam halo
- Installed in FEL gun in 2004
- Operational at 350kV for 3 years
- Operated reliably at 5-8 mA CW
- Stable FEL operation >8 mA CW limited by halo
- Similar as with sample "A", FEL operation > 8 mA CW often led to sudden beam stop
 - resulted in total loss of QE and produced damage spot
 - QE fully recovered by heat clean and subsequent NEA reactivation
 - observed increased beam halo after each event
- Removed from gun in 2007 during gun rebuilt after insulator puncture during HV conditioning

Sample "B" removed from gun in 2007

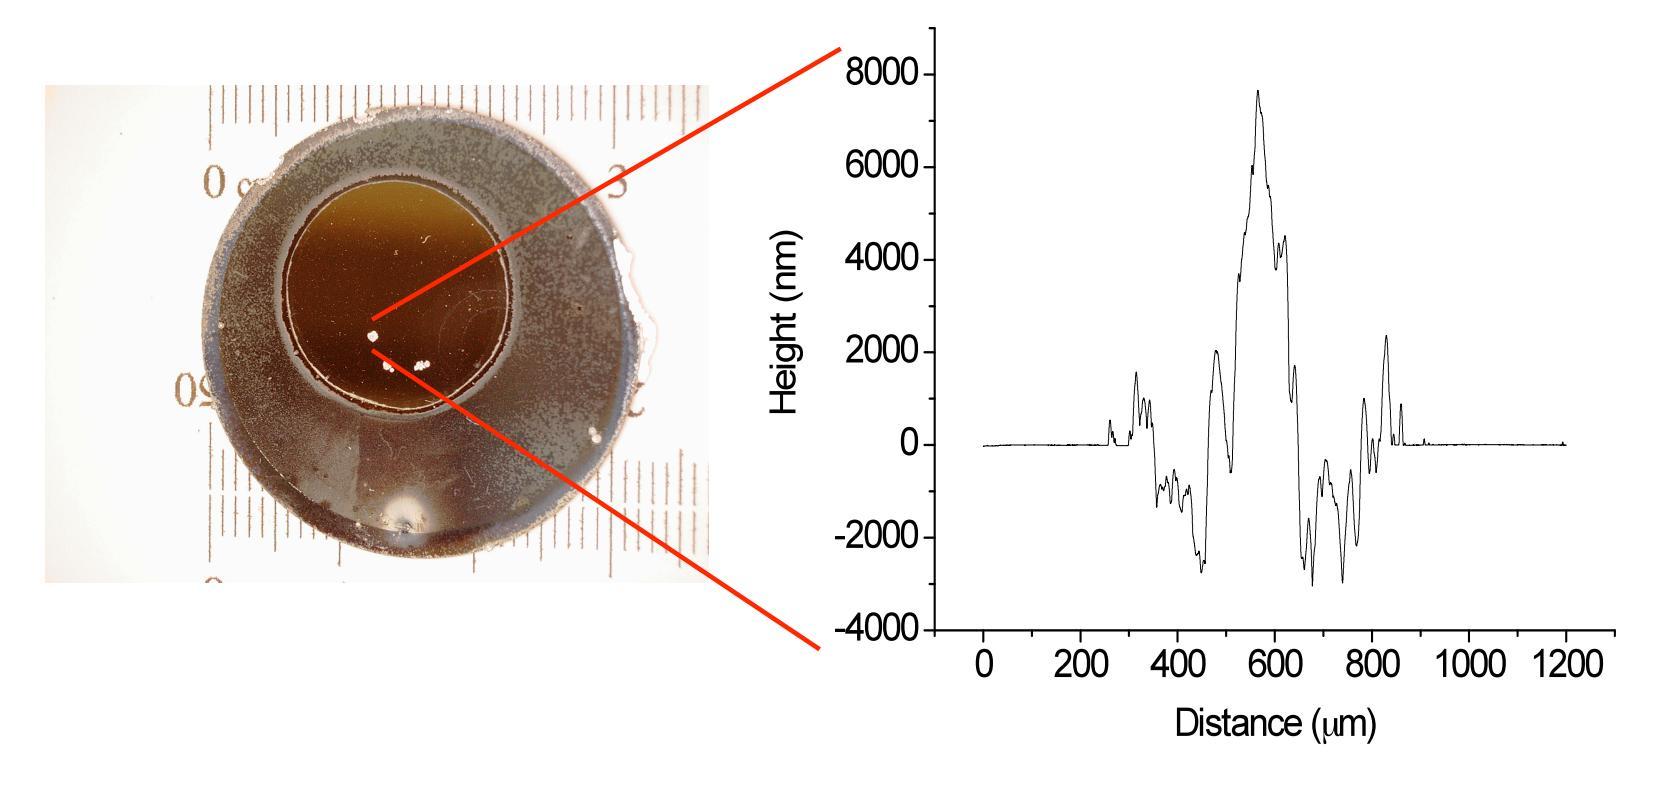
Profilometry measurements on one of the damage spots shows an 8 micron tall feature

All of the damage spots on both removed samples show similar profiles

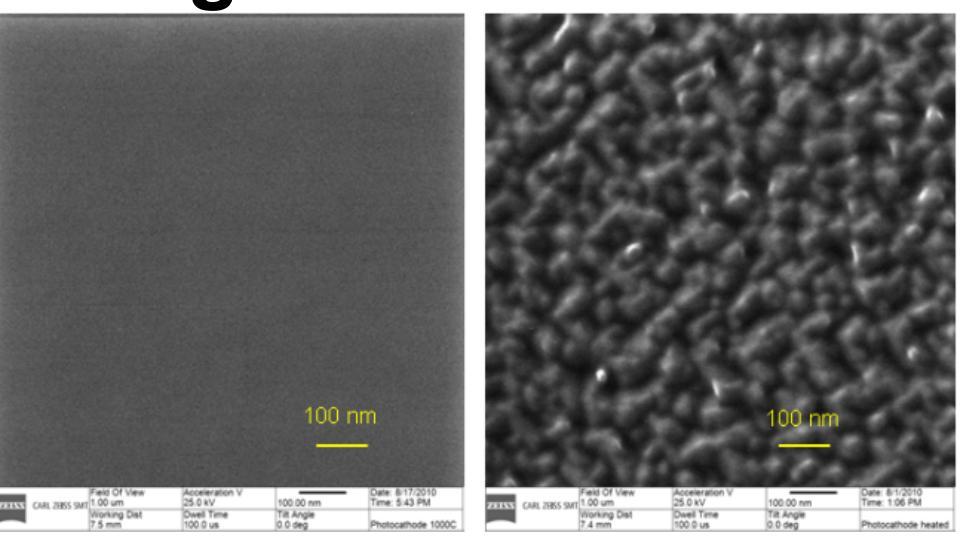
Helium Ion Microscopy is consistent with AFM roughness measurements...

Control No heat 0.2 nm

Heated 1 heat cycle 5.5 nm

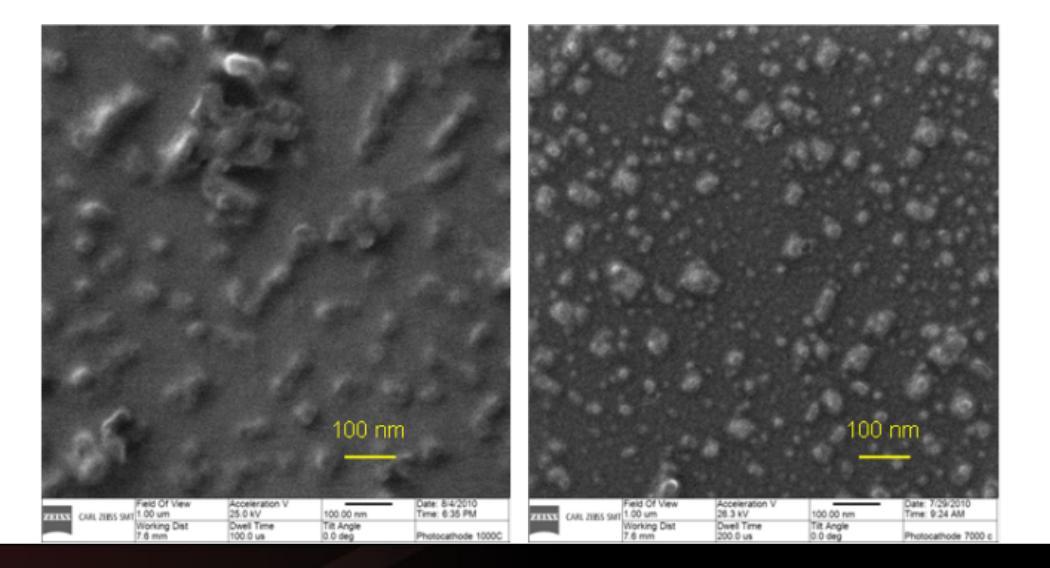
Sample A 12 heat cycles 4.6 nm

Sample B 9 heat cycles 4.0 nm

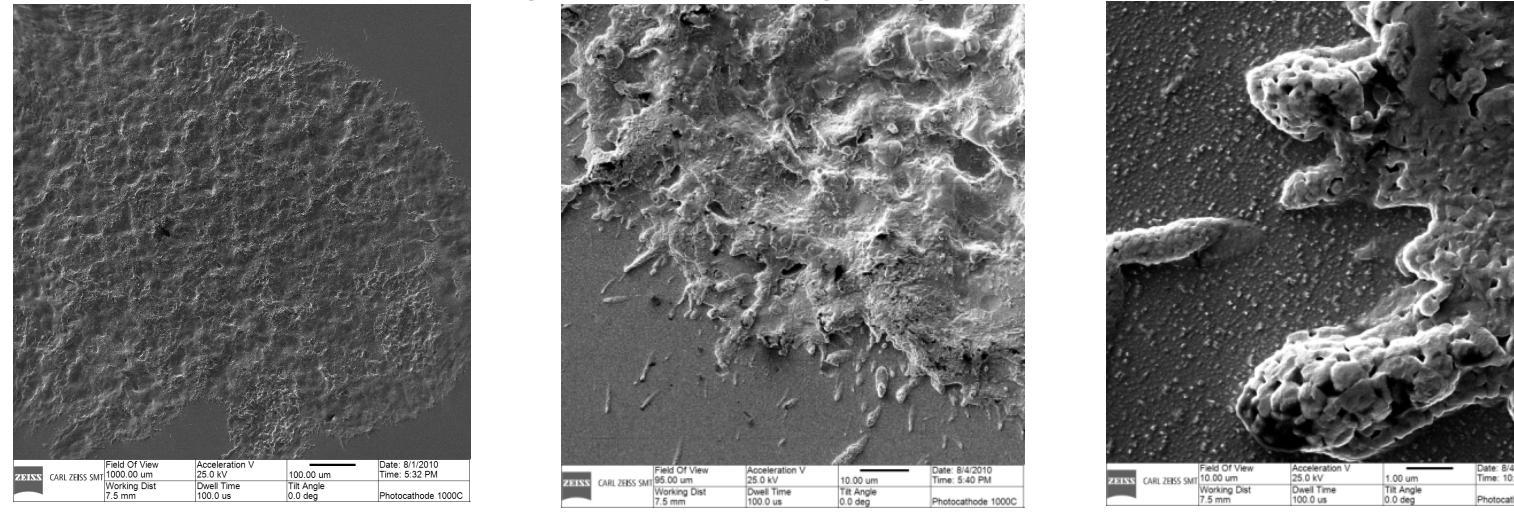
...and provides really cool images of damage spots Sample A HIM images at increasing magnification of damage spot

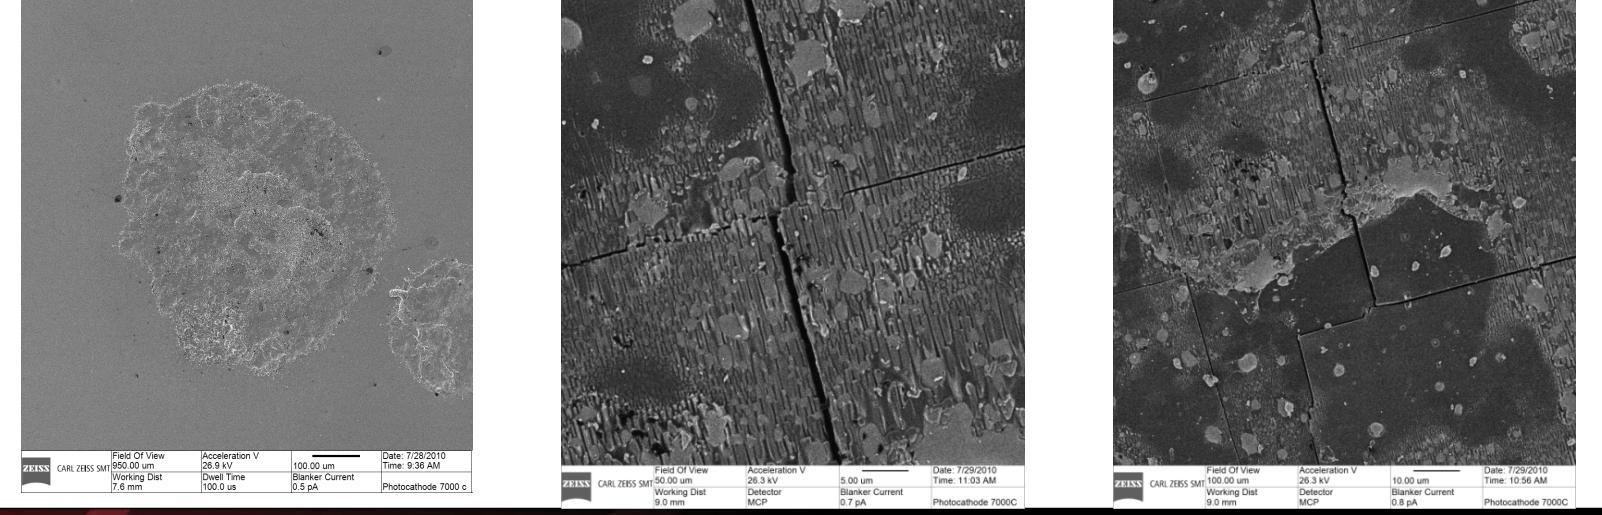
Sample B HIM images at increasing magnification of damage spot

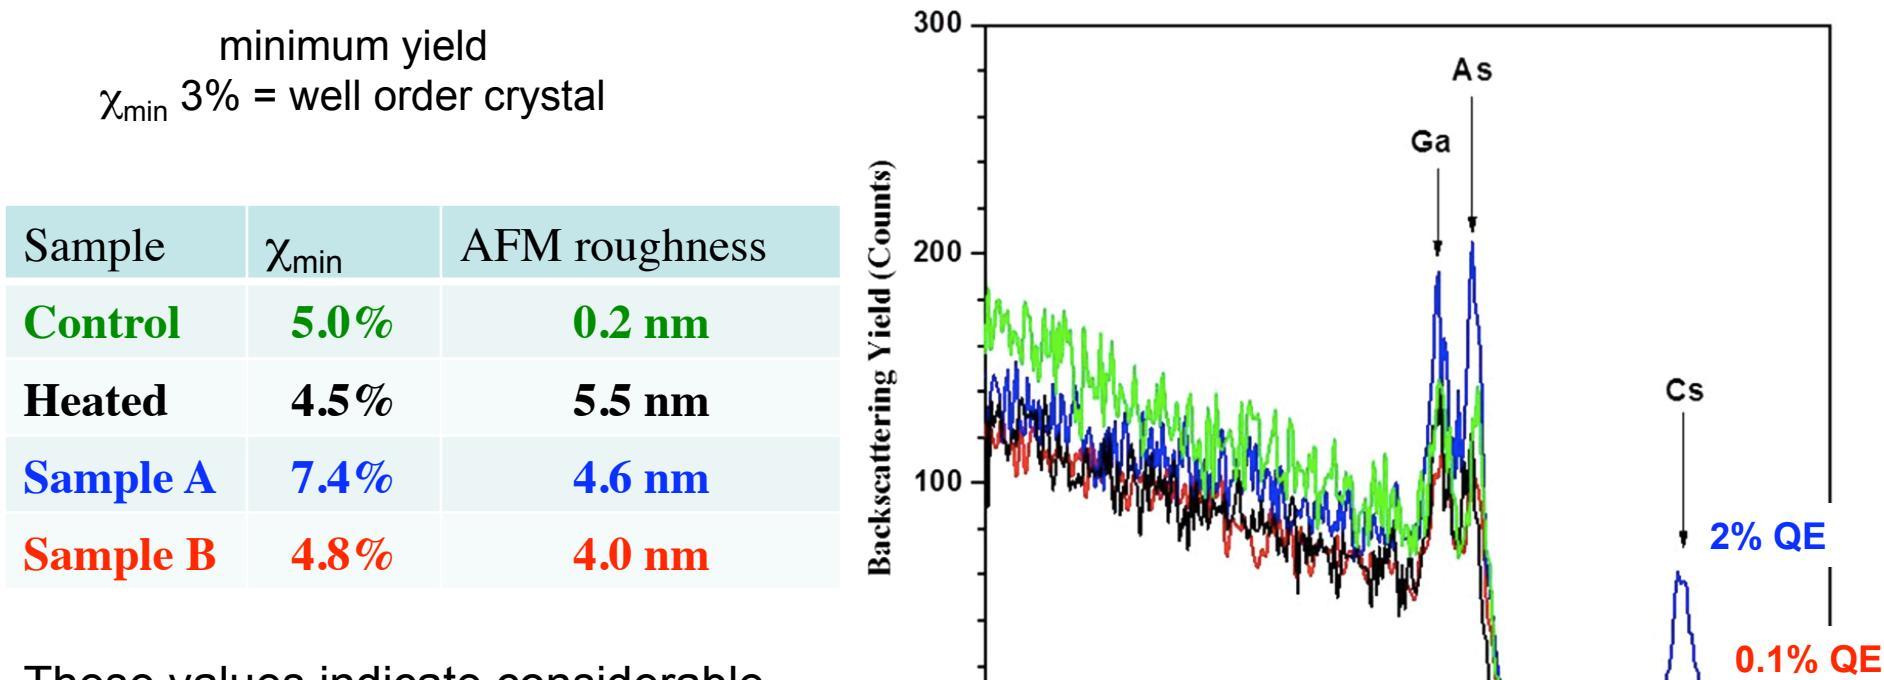
RBS results show evidence of surface Cs sputtering but no significant crystal damage

These values indicate considerable crystal order, with respect to the bulk of the crystal, even though these surfaces display well-defined nanostructures.

Channel Number RBS taken in the laser-illuminated region

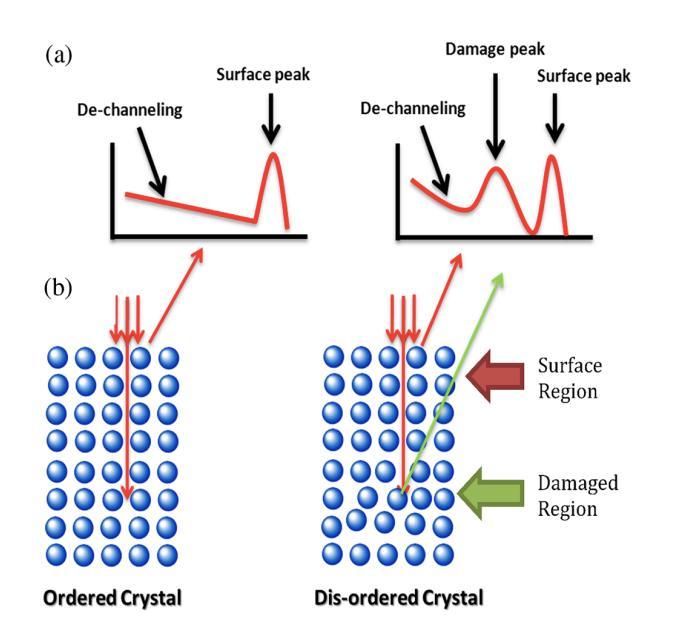
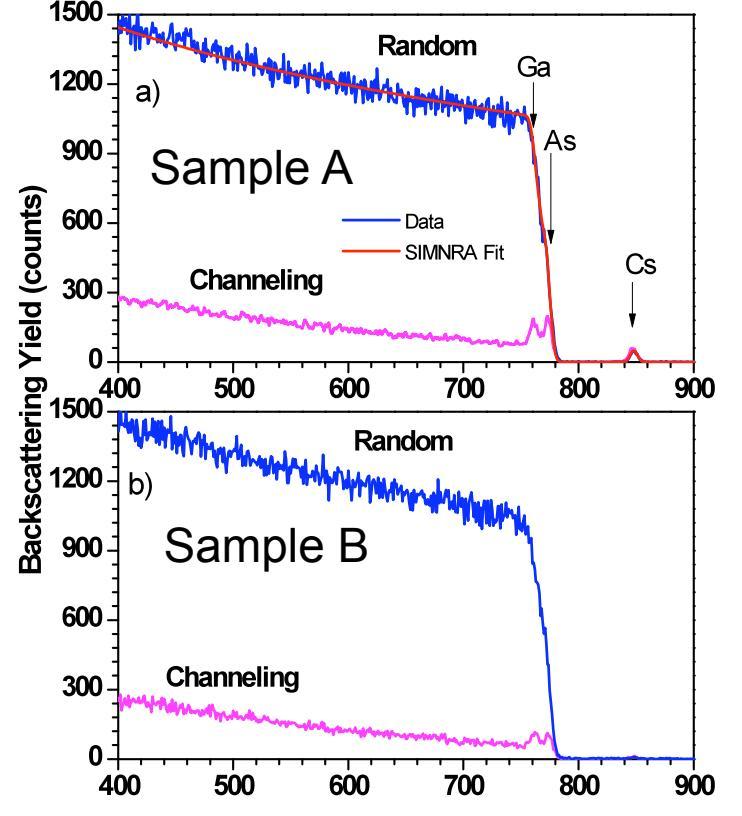
RBS shows no indication of crystal damage

If loss of QE is due to bulk wafer damage induced by ion back bombardment, then we would expect to observe damage peaks in the channeling spectrum.

Channel Number Calculations indicate that hydrogen implantation should peak at a depth of 1.5 μ m which, in turn, should lead to a damage feature near channel 450.

The channeling spectra do not show any evidence of damage peaks.

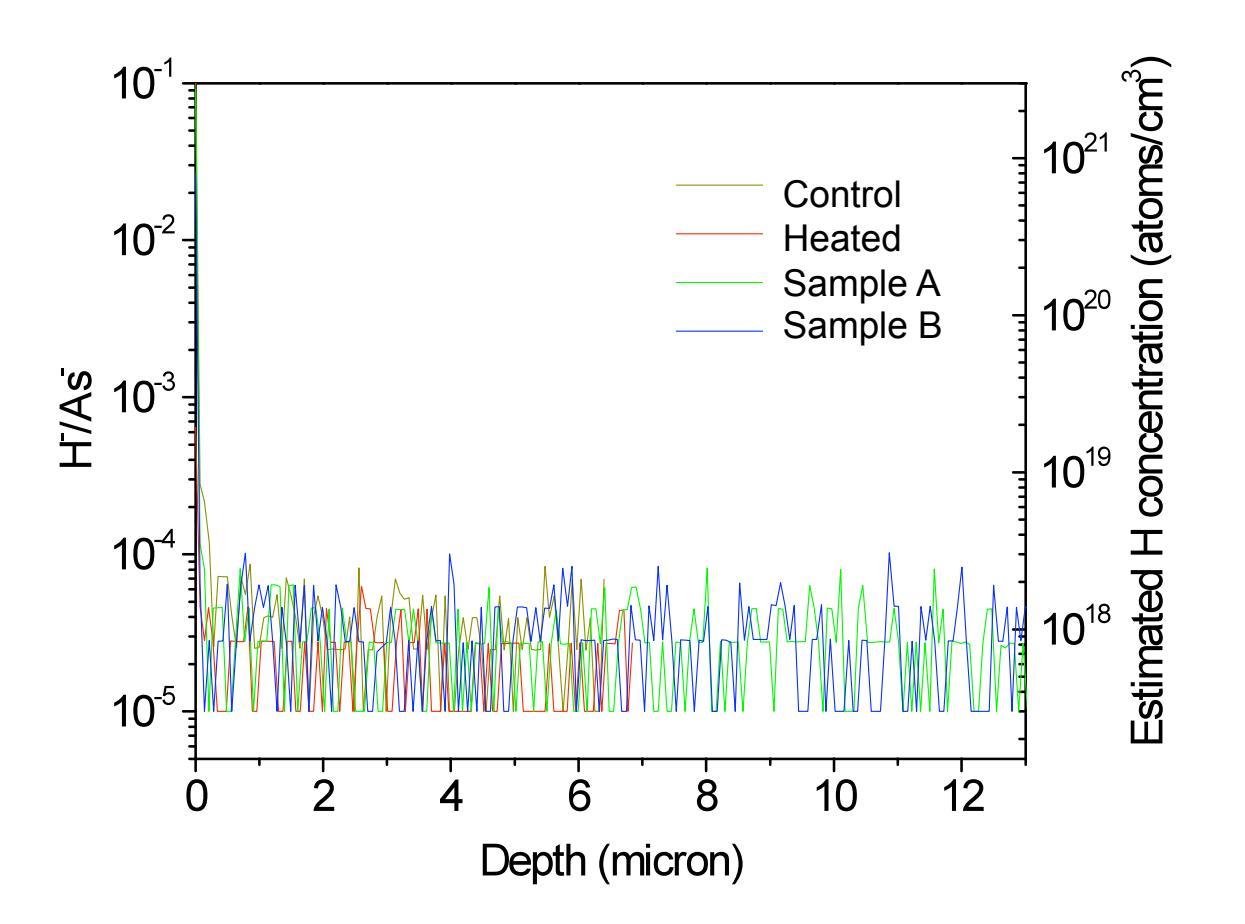
The SIMS depth profiles show no evidence of hydrogen implantation. Hydrogen concentrations in all the samples are lower than our detection limit of 1x10¹⁸ atoms/cm³

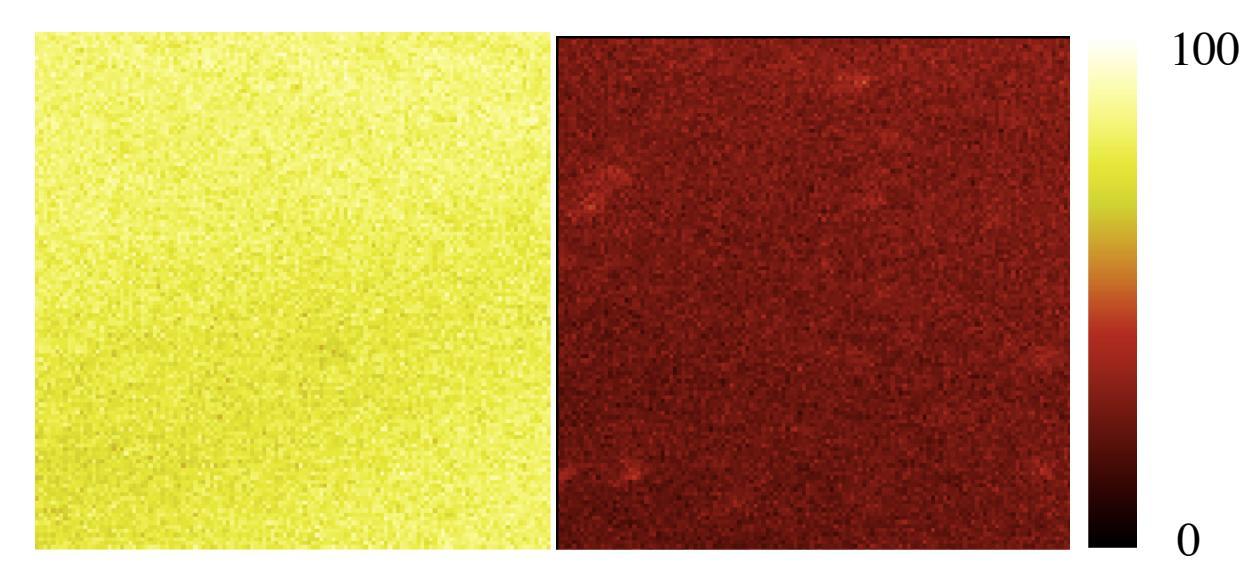
SIMS-measured Cs surface concentrations are consistent with those determined by RBS

Sample A, 2% QE prior to removal from gun

Sample B, 0.1% QE prior to removal from gun

Positive ion SIMS images obtained from sample A (1000 coulomb) and from sample B (7000 coulomb) showing relative Cs concentrations. The field of view in both is 150 μ m 150 μ m.
